TO: Owners and Operators of Model AA-1 Yankee and AA-1A Trainer Aircraft

SUBJECT: Carburetor Inspection

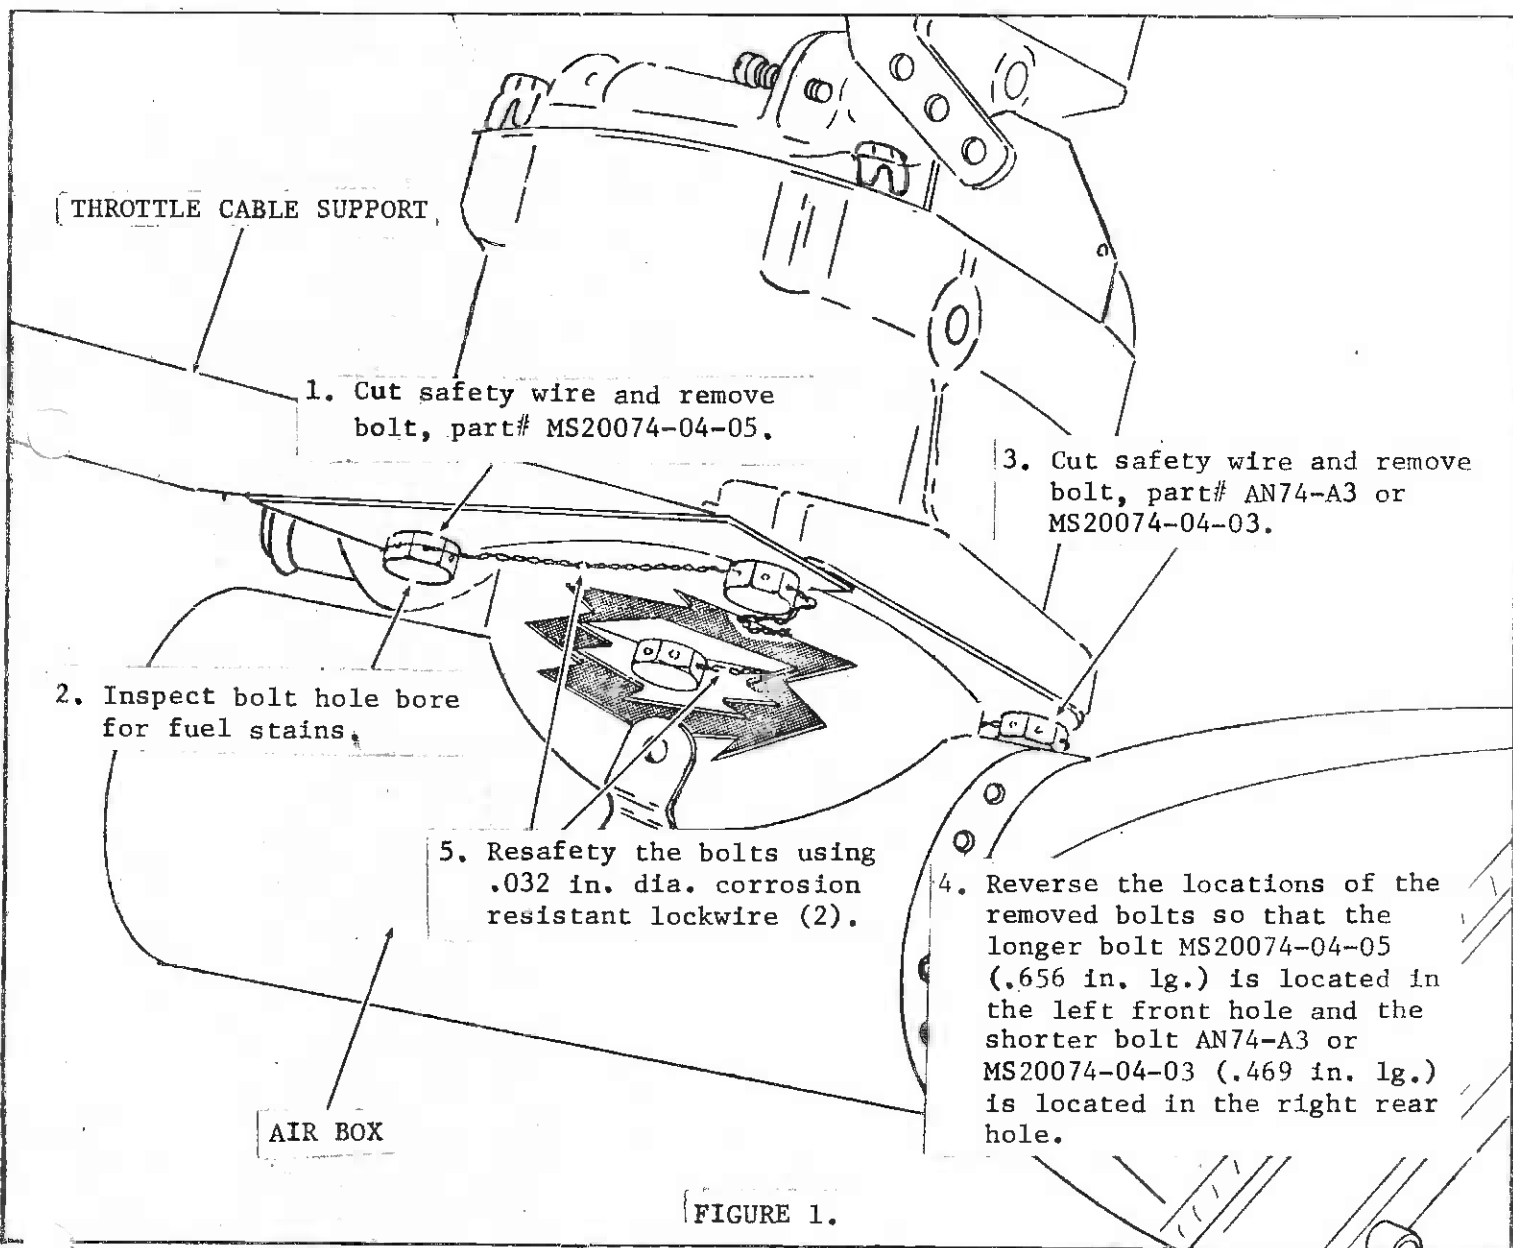
It has come to our attention that the MS20074-04-05 bolt which attaches the rear of the throttle control bracket and the carburetor air box to the carburetor is of such a length that bottoming of the bolt in the attach hole in the carburetor can occur with resultant cracking of the boss inside the carburetor fuel bowl. To confirm that the carburetor is not cracked, the following must be accomplished as indicated:

Visually inspect the right rear lower bolt area of the carburetor for fuel stains. If stains are present, perform the Subsequent Inspection, steps 1 through 4 below, before further flight.

If stains or other indications of leaking are not present, comply with the Subsequent Inspection and bolt relocation instructions 1 through 4 below within 5 hours of operation, but no later than 14 days after date of this Bulletin. See Figure 1.

1. Remove lower cowl - cut safety wire and remove right rear MS20074-04-05 bolt from throttle cable support and air box attach to carburetor.
2. Inspect bolt hole bore in carburetor for fuel stains. If fuel stains are present, the carburetor must be removed from service.
3. Remove the AN74-A3 or MS20074-04-03 bolt from the left front air box attach point and install in place of the MS20074-04-05 bolt in the right rear corner. Install the MS20074-04-05 bolt in the left front corner and resafety all bolts.
4. Make log book entry showing compliance with this Service Bulletin. Complete and mail attached Service Reply Card.
