DATE: January 18, 1972

SUBJECT: Control Surface Bearing Support Inspection

SERIALS AFFECTED: AA1A-0095 thru AA1A-0158, AA1A-0160 thru AA1A-0215, AA1A-0217 thru AA1A-0250, AA1A-0253 thru AA1A-0272, AA1A-0274, AA1A-0276 thru AA1A-0290, AA1A-0292 thru AA1A-0294, AA1A-0296 thru AA1A-0299, AA1A-0301, AA1A-0304 thru AA1A-0307, AA1A-0309, AA1A-0314, AA1A-0318 and AA1A-0320 thru AA1A-0323.

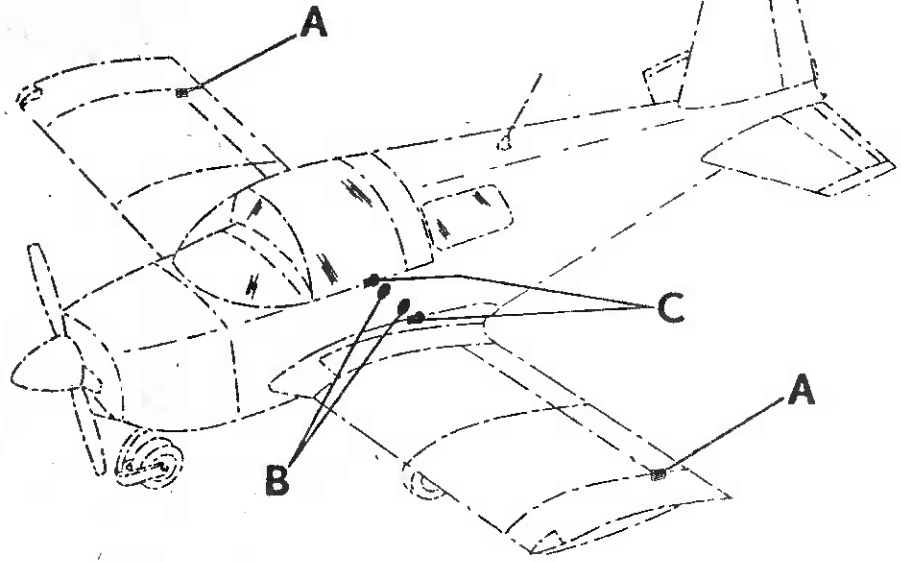
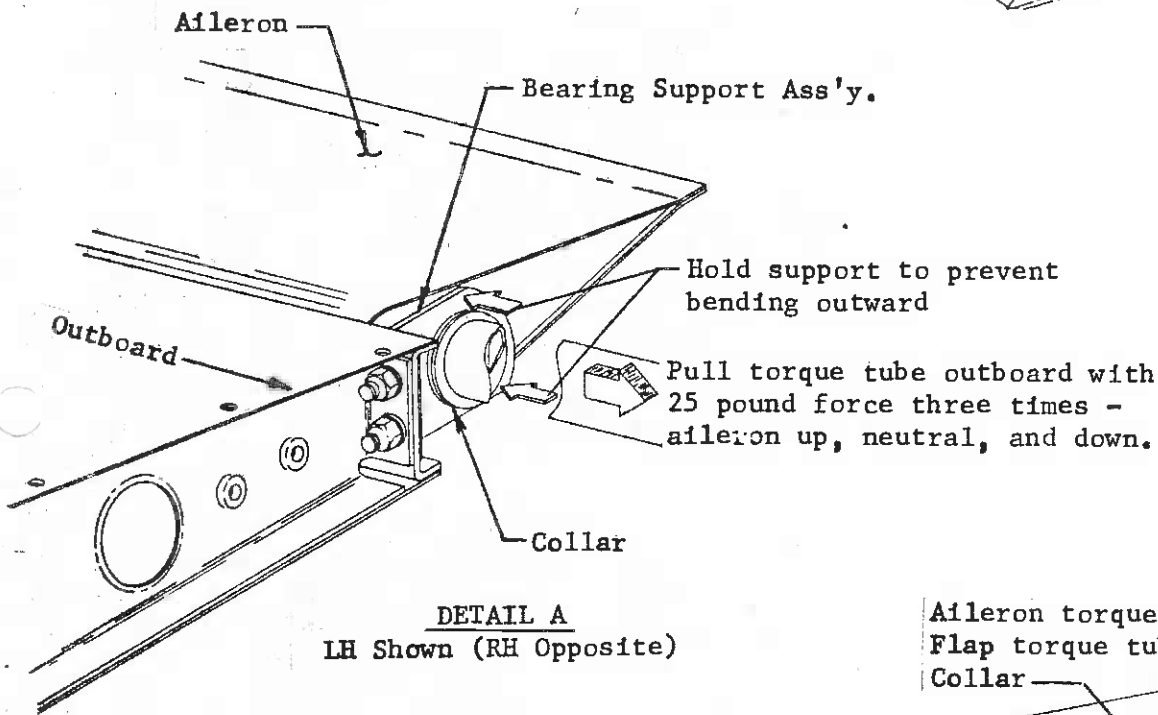
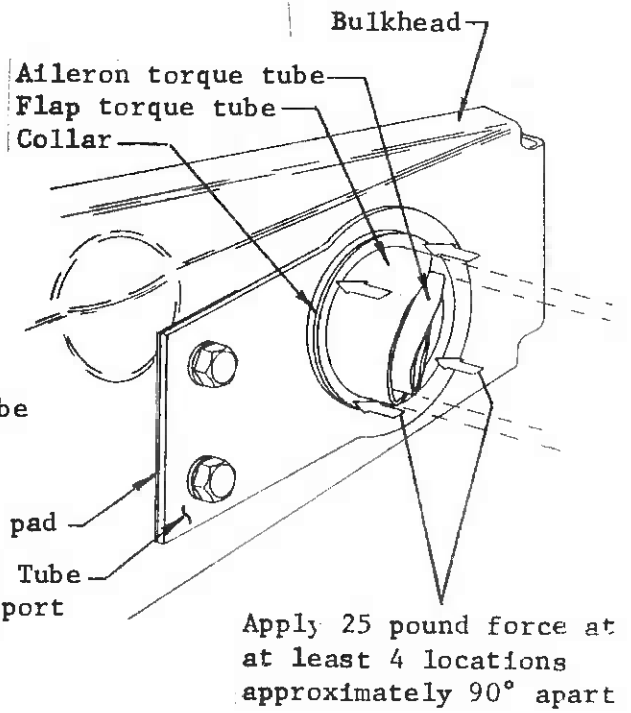
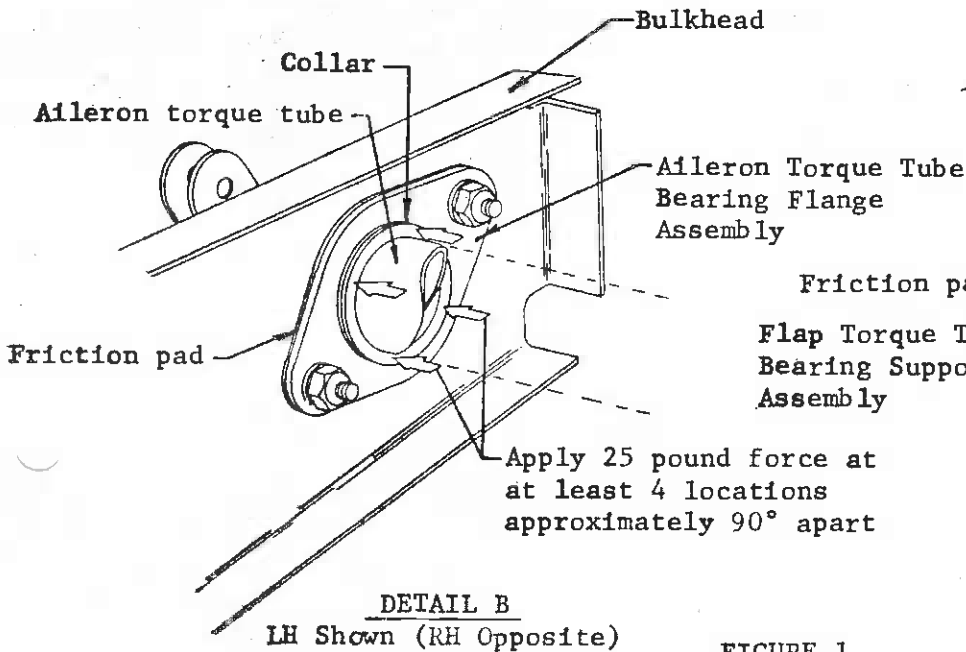
**FIGURE 1.**

It has come to our attention that some of the above aircraft may have been produced with control surface bearing support assemblies that were improperly machined and/or assembled. This improper machining and/or assembly could result in the bearing supporting collar becoming loose in the support bracket/flange. In most instances, looseness of the bearing support collar in the bracket or flange would simply result in rotation of the collar within the bracket/flange and would be of no particular concern as the collar is adequately restrained by the control surface and shims.

There are three (3) critical areas in the aircraft where the above discrepancy could result in excessive looseness of the control surface assembly due to the bearing collar not being restrained. These areas are the outboard aileron bearing support, located adjacent to the wing tip, the inboard aileron torque tube support and the inboard flap torque tube support located under the baggage compartment floor.

1. Remove wing tips. Hold bearing support to prevent bending outward. Grasp aileron torque tube and pull outboard with a 25 pound force. Apply force three times - aileron up, neutral and down.
2. Any visible movement between collar and support is cause for rejection and rework or replacement of the support assembly.

1. Lift up baggage floor covering and remove inspection covers.
2. Locate bearing support/flange assemblies. Apply 25 lbs. of force at approximately each 90° around the collar circumference using the extremes allowed by raising and lowering the flaps and ailerons.
3. Any visible movement between collar and support/flange is cause for rejection and rework or replacement of the support/flange assembly.

1. Remove aileron counterbalance. (*Caution - Note location of bolt spacers inside aileron torque tubes*) Remove bearing support assemblies from rear wing spar and slide them off torque tube noting number and location of spacers.
2. Install in reverse order installing spacers in same position to assure minimum endplay.

1. Detach outboard aileron bearing support assembly from rear spar.
2. Disconnect aileron bellcrank from inboard end of aileron torque tube. (Do not disturb control system rigging)
3. Slide aileron assembly outboard far enough that torque tube is slid out of inboard bearing flange assembly. Mark original installed position and remove bearing flange assembly from bulkhead noting location of friction pad between bulkhead and bearing flange.
4. Install in reverse order. Use caution in reassembling and do not apply excessive force to bearing collars or brackets which may cause bending of the bearing brackets.

1. Complete all steps shown above under installation of inboard aileron bearing/flange assembly except do not remove flange assembly from bulkhead.
2. Disconnect flap bellcrank from flap torque tube.
3. Detach bearing support assembly from bulkhead, noting location of friction pad between support assembly and bulkhead and slide support assembly off torque tube.
4. Reassemble in reverse order noting that friction pad must be installed between bearing support assembly and bulkhead and that bearing support assembly location must be adjusted so that flap torque tube is concentrically located around aileron torque tube.
