SERVICE BULLETIN NO. 168

AILERON TORQUE TUBE JOINT INSPECTION

All AA5A and AA5B aircraft equipped with Service Kit SK 150 modified ailerons. All AA5 aircraft equipped with Service Kit SK 150 modified ailerons and the 5202035-505 aileron torque tube assembly.

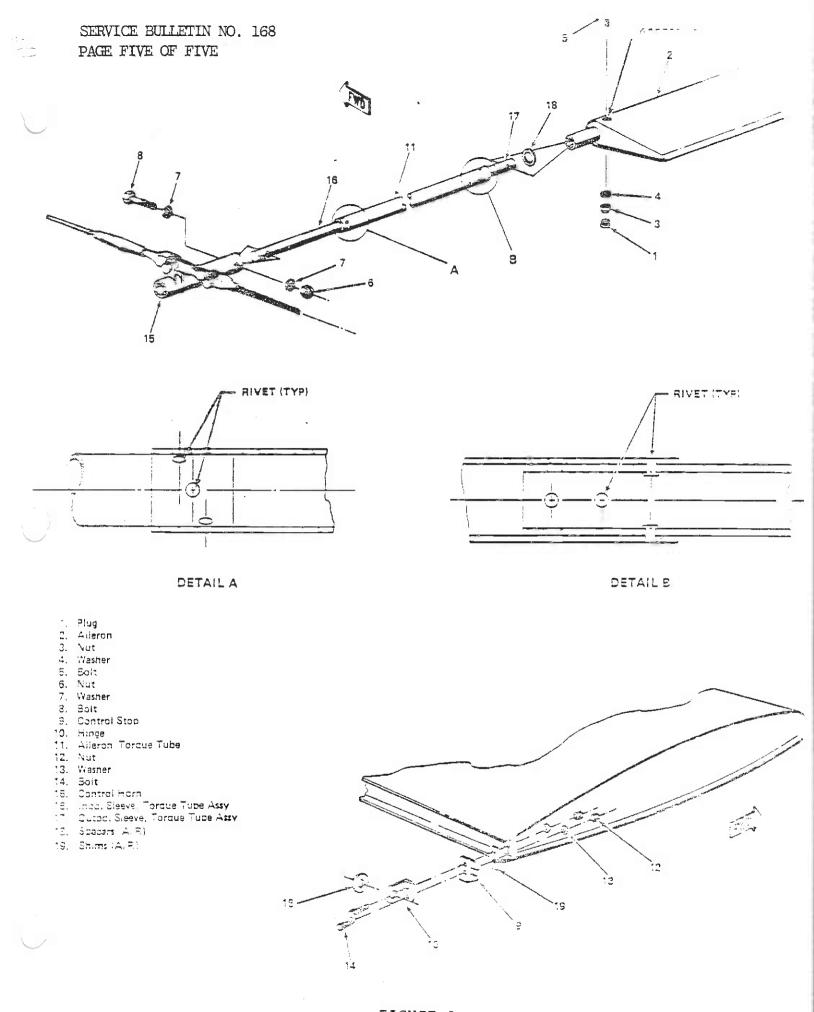
FIGURE 1

There have been reports of some aileron torque tube joints working loose. Service Bulletin No. 163 covers all ailerons on aircraft AA5A-0176 through AA5A-0805, AA5B-0302 through AA5B-1078 and all spare stock Part No. 5202035-505 shipped from the factory between May, 1976 and January, 1979. Service Bulletin No. 165A covers all AA5 series except those aircraft with ailerons modified by Service Kit SK 150.

This Service Bulletin is directed at those aircraft (AA5A and AA5B) with ailerons modified by Service Kit SK 150, and all AA5 aircraft with ailerons modified by Service Kit SK 150 and the 5202035-505 aileron torque tube assembly. Referring to Figure One (1), the aileron torque tube assembly requiring inspection consists of a tube, Part No. 5202035-11 (11) an inboard sleeve, Part No. 5202035-6 (16), and an outboard sleeve, Part No. 5202035-11 (17).

- A.) Aileron/torque tube removal (REFER TO FIGURE 1)
 - (1) Remove wing tip as described in Chapter 57 of AA-5 series Maintenance Manual.
 - (2) Remove plugs (1) from inboard end of aileron (2). Remove nut, (3), washer (4), and bolt (5).
 - (3) Remove nuts, (12), washers (13), and bolts (14) from wing. Note installation, if installed, of spacers (18) and shims (19). Mark position of control stop (9) and aileron hinge (10), then remove from wing. Disconnect ground terminal.

- (1) Inspect both inboard and outboard torque tube joints for looseness.
- (2) If joints are loose, joints will have to be reworked as per instructions in Service Kit SK 144.
- (3) Upon completion of inspection and, if necessary, modification torque tube can be returned to service.
