AMERICAN GENERAL AIRCRAFT SERVICE BULLETIN No.176

ALTERNATOR LIGHT CIRCUIT MODIFICATION

99998, 10000 THROUGH 10033

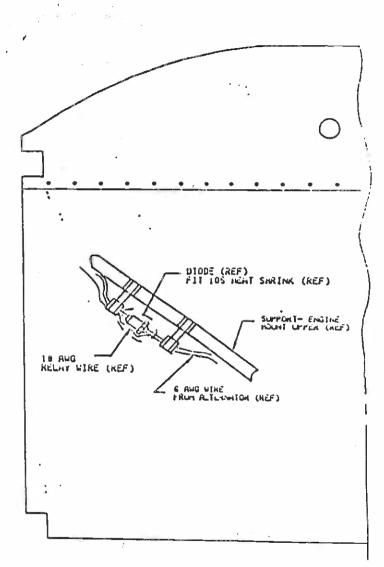
Figure 1. Relay energizer wire routing.

I. Relay energizer wire (location: engine mount, right side) Serials: 99998, 10000 through 10020

Relay energizer wire must <u>not</u> be enclosed in power diode heat shrink to prevent possible insulation damage to relay energizer wire by diode heat and chafing. Inspect routing and replace heat shrink as required.

(1) Locate 18 AWG relay wire attached to power diode, leading from alternater, Figure 1.

(2) If routed through heat shrink tubing wraped around diode: (a) remove heat shrink tubing (b) inspect wire for insulation damage and if damage is present, incase wire in 1/8" heat shrink tubing.
(c) replace heat shrink tubing with 18 AWG wire routed outside of heat shrink tubing.

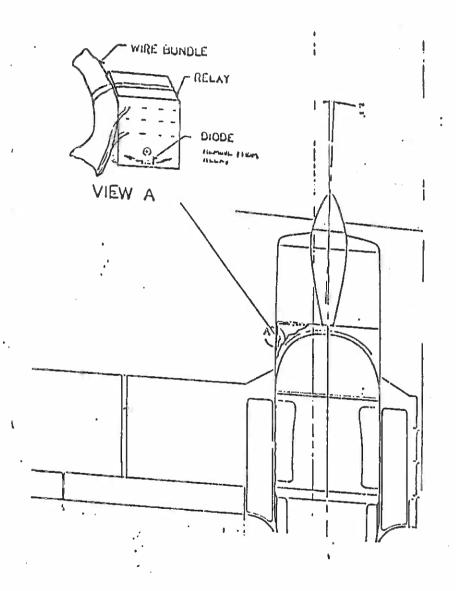
Figure 2. Relay transient protection diode.

II. Relay transient protection diode (location: left side fusclage, below instrument deck)

The diode is not required and presents a possible short to ground between the relay terminals.

(1) Locate relay in harness bundle, between stall warning horn and avionics cooling fan, Figure 2.
