**American General  
Aircraft Corporation**

**SERVICE BULLETIN NO. 177**

SUBJECT: INSPECTION OF AILERON TORQUE TUBES

MODEL/SERIAL EFFECTIVITY: AG-5B 99998 & 10000 - 10073 (IMMEDIATE INSPECTION)  
All AA-5, AA-5A, AA-5B, & AG-5B aircraft (ANNUAL INSPECTION)

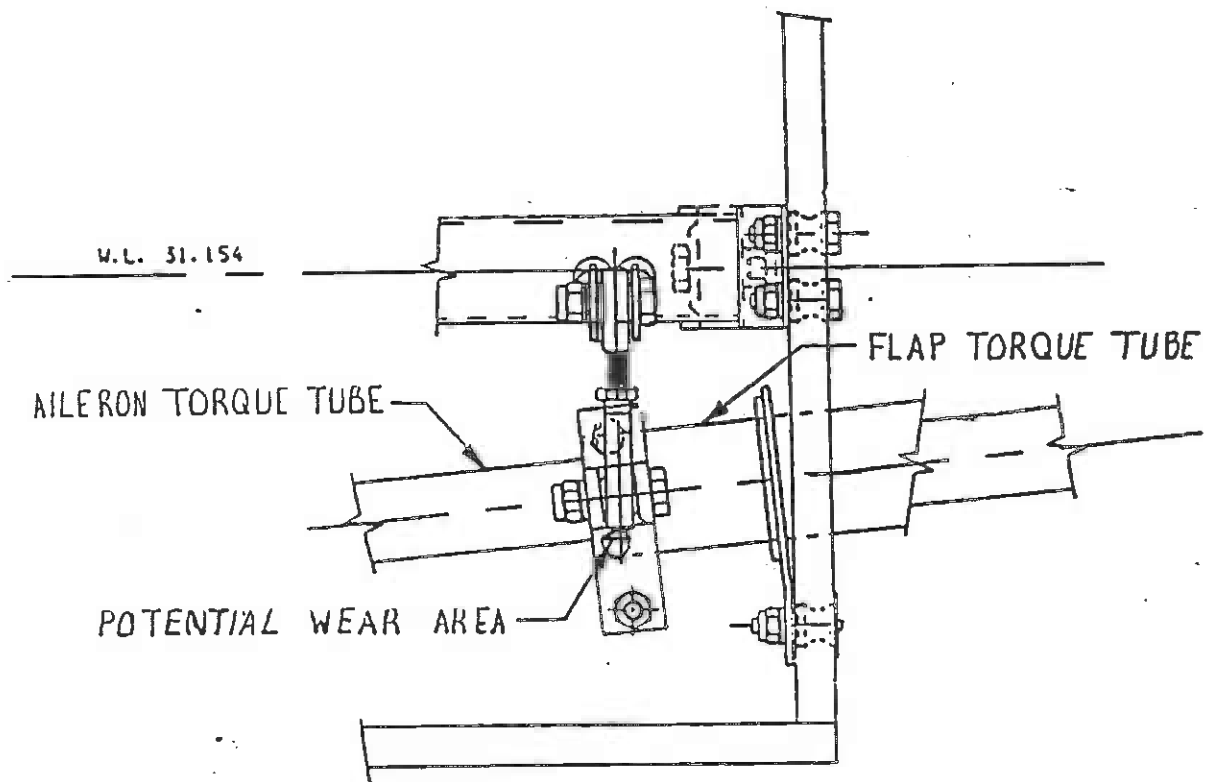
FIGURE 1

The aileron torque tube assemblies (part no. 5202035-507) in some AG-5B aircraft have been found with excessive wear due to misalignment of the aileron torque tube to the flap torque tube. The wear occurs at the point where the flap torque tube is attached to the flap drive tube under the rear seat of the aircraft.

1. Remove rear seat back cushions, fold out rear seat bottom and remove canvas cover.
2. Examine the area indicated in Figure 1 for alignment of the two torque tubes and for any signs of flap drive bolt contact and wear. If the inside diameter of the flap torque tube is closer than 0.060 inches from the aileron torque tube or if any signs of bolt contact or wear are found then repair or replacement of the aileron torque tube becomes necessary.

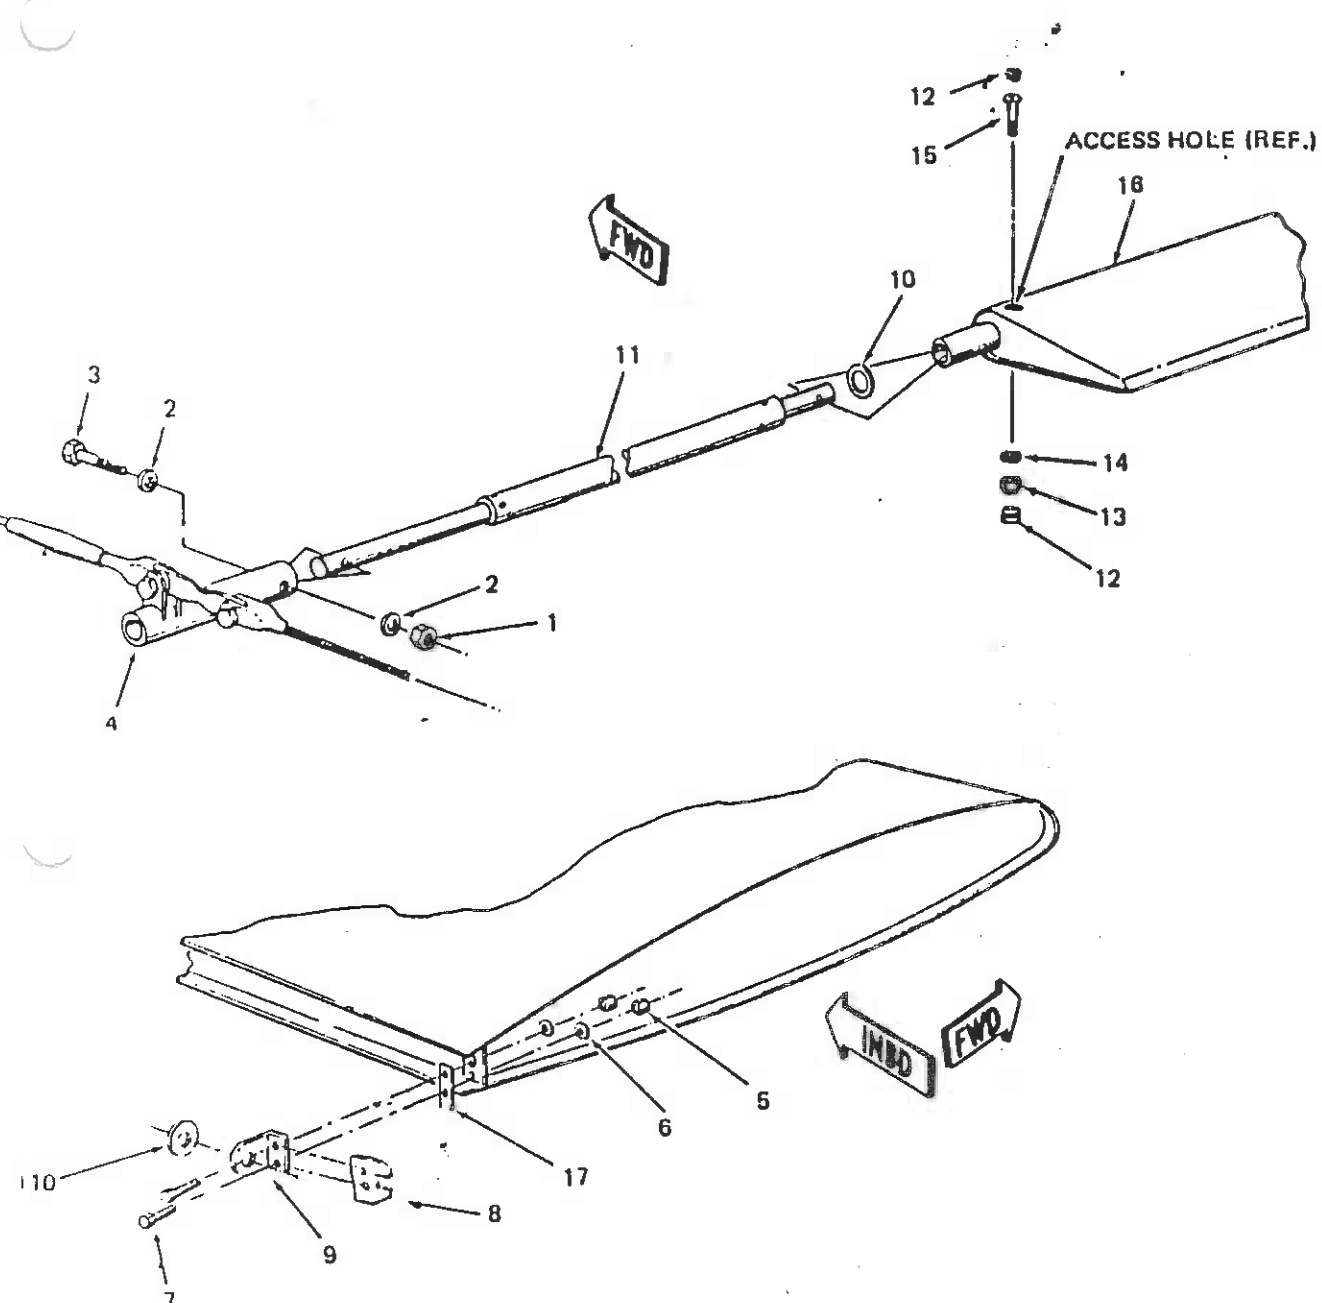
FIGURE 2

If the inspection of the aileron torque tube reveals any damage then the following procedure must be completed (refer to Figure 2). If the wear on the torque tube is deeper than 0.030 deep then the torque tube can not be repaired and must be replaced.

1. Remove wing tip as described in Chapter 57 of AA-5 series Maintenance Manual.
2. Remove plugs (12) from inboard end of aileron. Remove the nut (13), washer (14), and bolt (15) from the aileron torque tube.
3. Remove nuts (7), washers (6), and bolts (5) from wing and aileron bearing bracket. Remove control

6. Pull aileron torque tube assembly outboard and remove it from the aircraft.
7. Check the depth of the wear marks on the torque tube. If the marks are more than 0.030 inches deep then the torque tube must be replaced. If the marks are 0.030 inches deep or less then the damage may be smoothed out carefully by using a file and fine grit sandpaper. Caution: do not increase the depth of the damage beyond 0.030 inches during this process or the torque tube will have to be replaced.

12. Loosen the aileron and flap bearing bracket bolts inside fuselage and adjust the bearings as required to obtain a minimum clearance between the aileron and flap torque tubes of 0.160 inches.
