## CRITICAL SERVICE BULLETIN

**SB-189**

SUBJECT: **MISSING RIVETS**

MODEL / SERIALS AFFECTED: AG-5B 99998, 10000 through 10174

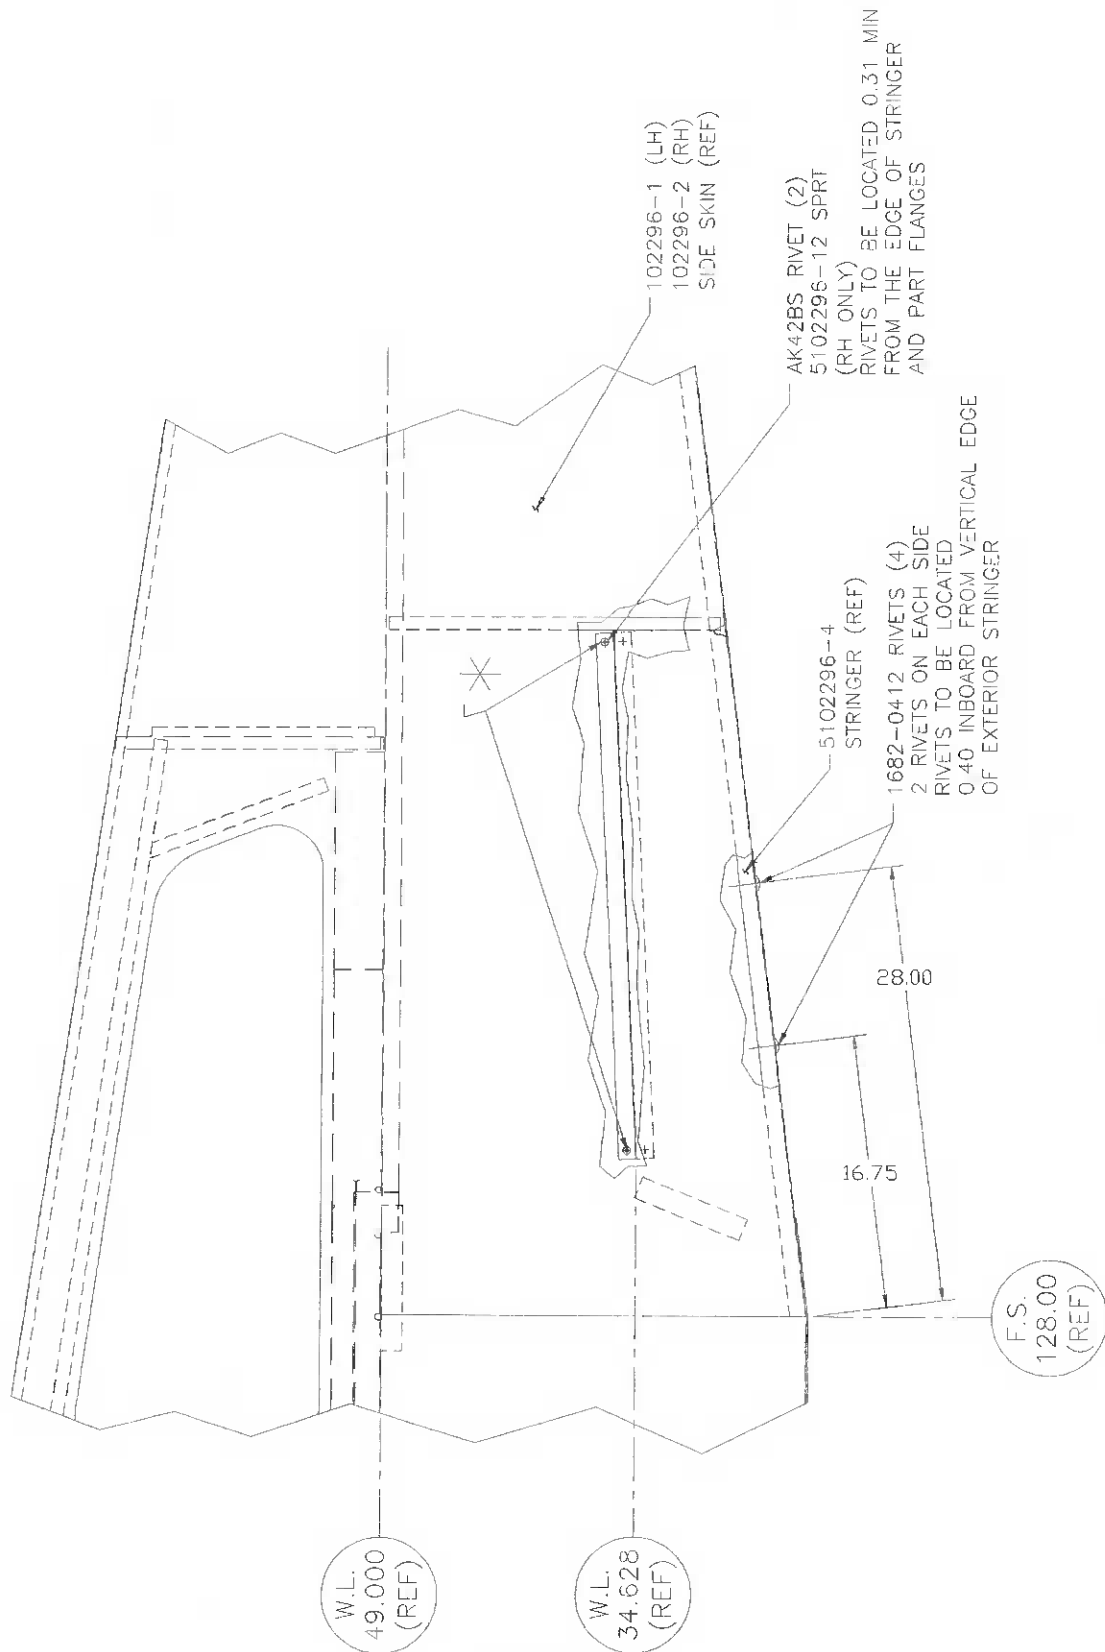
FIGURE 1

1. Prepare the aircraft for safe maintenance.
  - a. Disconnect the battery
  - b. Connect the airframe to a suitable ground
2. Remove the carpet and inspection panel from the baggage compartment floor.
3. Using a light and mirror, inspect for the presence of four (4) 1682-0412 rivets through the bottom, LH and RH edge of the fuselage and two (2) AK42BS rivets through the RH side of the fuselage above the baggage floor as noted in **Figure 1**.

1. Drill #30 holes and install all rivets missing from the locations noted above. All rivets should be installed "wet" with Zinc Chromate primer or equivalent.

**NOTE 3:** (\*) Indicates rivet hole locations, noted in **Figure 1, 2 and 3**, that have predrilled holes in the stiffener. These holes may be filled with bonding material. Remove the excess bond material to reveal these pilot hole locations and back drill through the stiffener using a #30 drill.

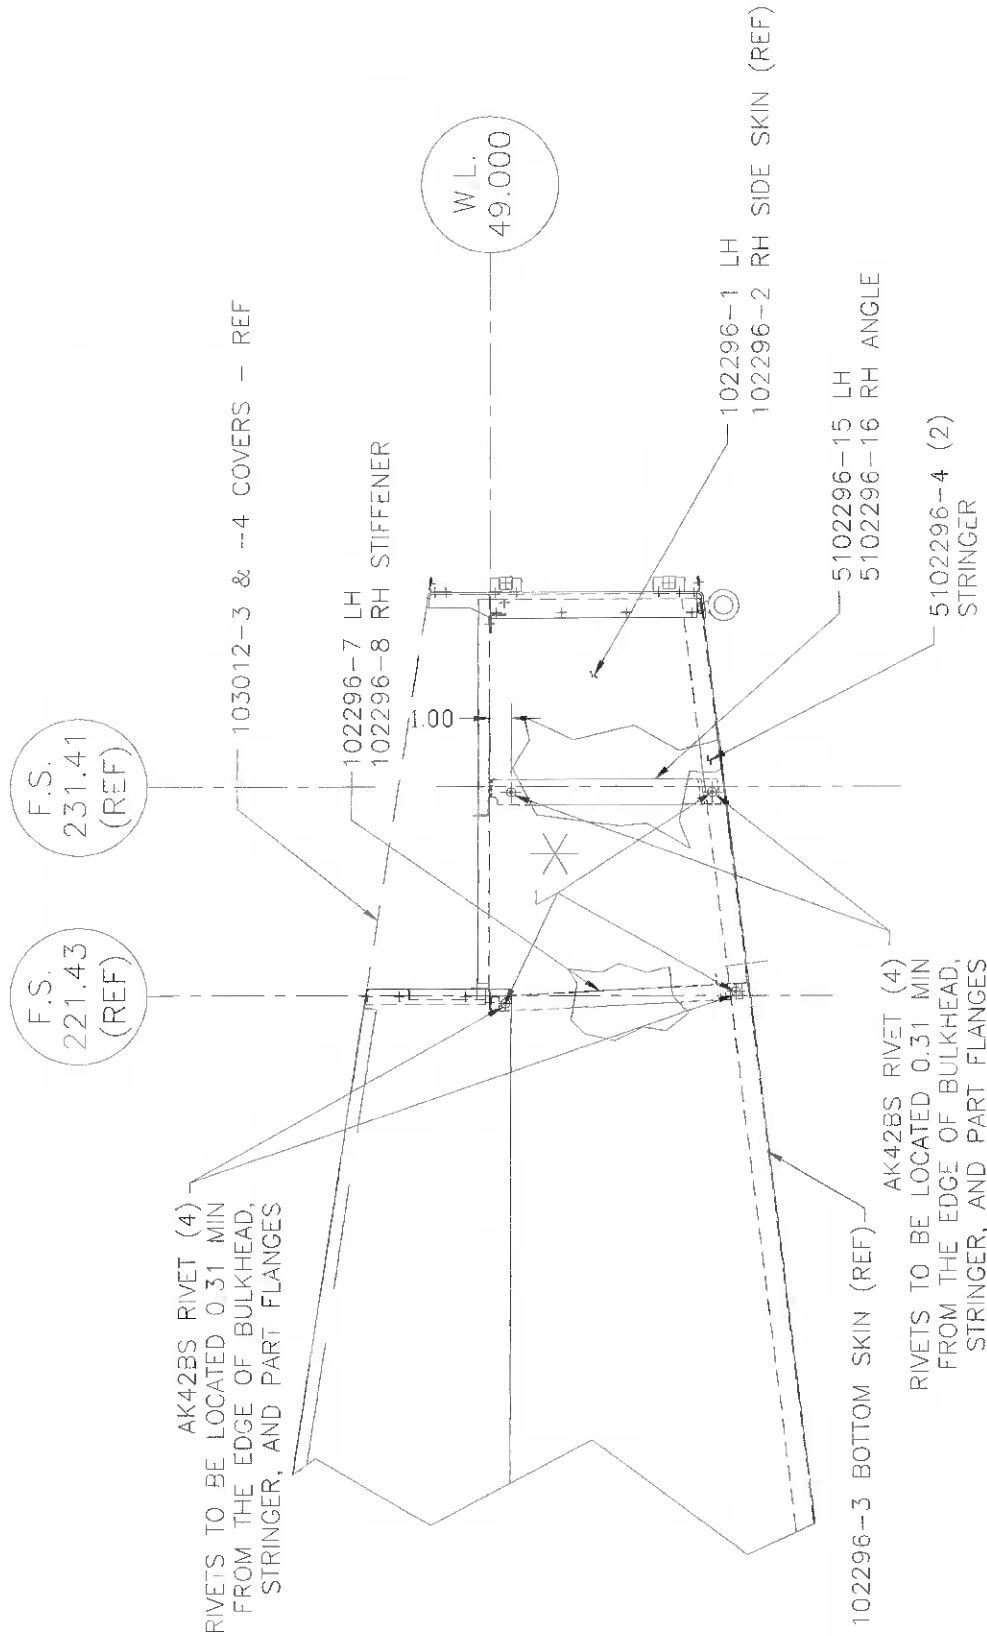
**FIGURE 2**

4. Remove the RH and LH Covers P/N 103012-3&-4 at the base of the vertical stabilizer. Inspect for the presence of eight (8) AK42BS rivets through the LH and RH sides of the aft fuselage, **Figure 2** and four (4) 1691-0410 rivets as noted in **Figure 3**.
5. Inspect the areas noted for any bond line delamination. Report any delamination found to Tiger Aircraft. Delamination repairs should be accomplished in accordance with Service Kit 125A. Copies of this service kit may be obtained by contacting Tiger Aircraft at the address listed below.

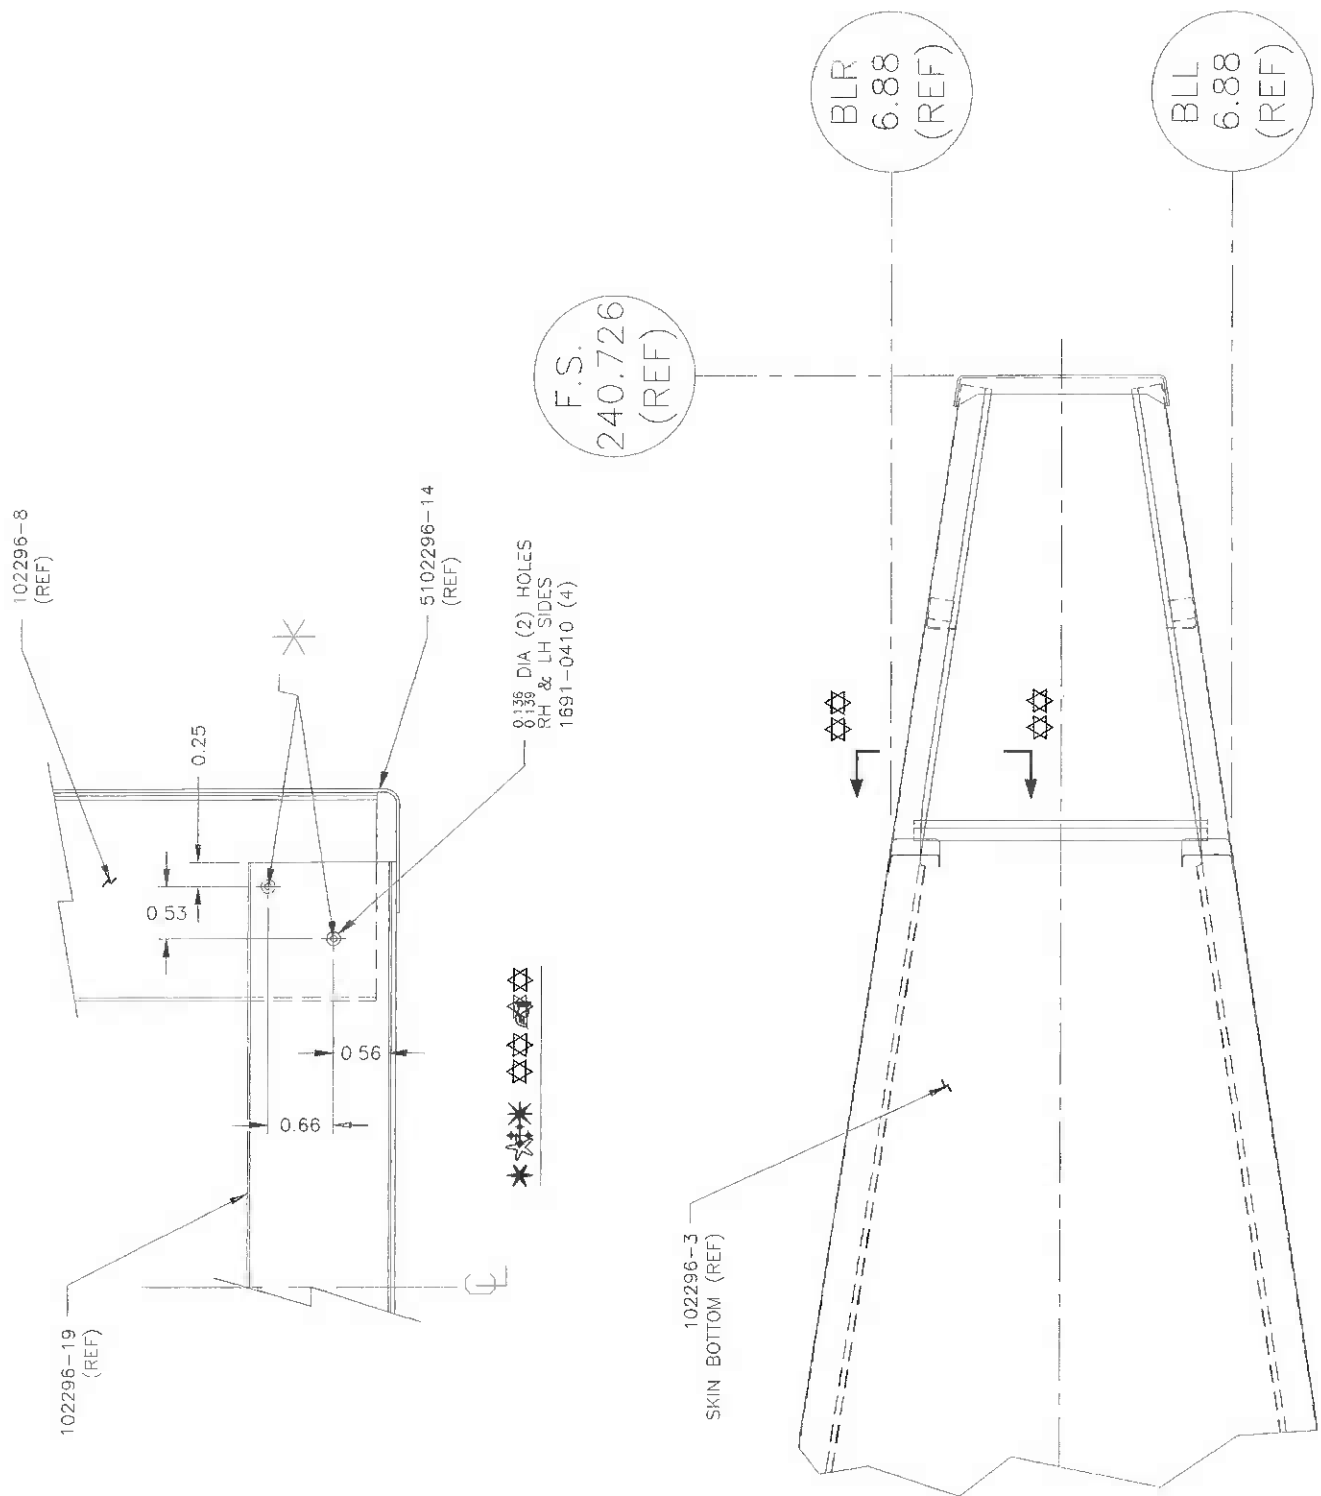
FIGURE 3

**NOTE 2:** The four (4) rivets noted in **Figure 3** do not protrude through the outer skin of the fuselage.
