SERVICE BULLETIN

SB-194

SUBJECT: **CONTROL COLUMN BEARING LUBRICATION**

MODEL / SERIALS AFFECTED: AG-5B 10201 through 10251

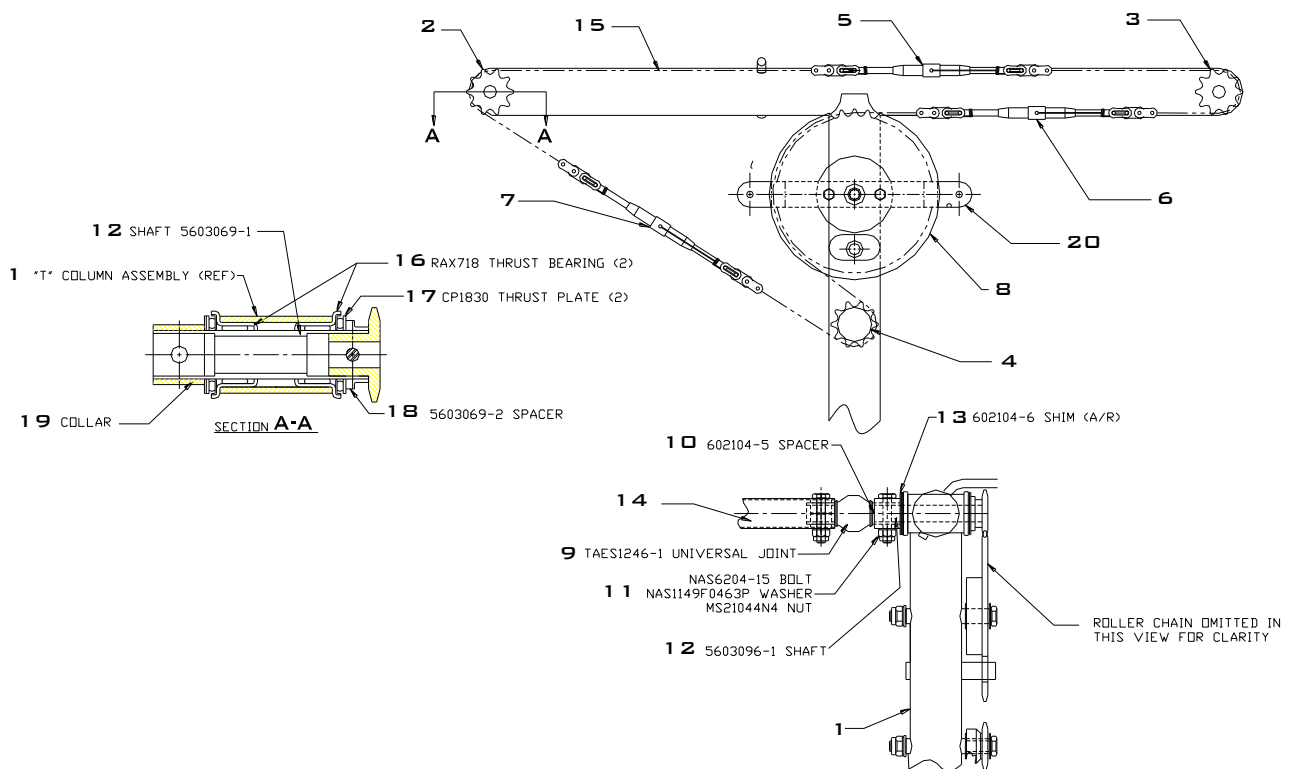
FIGURE 1

We have received a report of aileron control binding caused by failure of one or more of the four RAX718 Thrust Bearings installed in the 5602104-504 Control Wheel Column Assembly. The cause of the bearing failure was determined to be the absence of lubrication in the bearing. It is suspected that there may be additional aircraft in the above serial number range that had the RAX718 bearings installed without lubrication during the manufacturing process. If left undetected and not corrected, this condition could lead to the binding of the bearings and loss of aileron control, resulting in possible loss of controlled flight.

- (1) Inspect the bearings for the presents of grease. If the bearing are dry (no grease), install new RAX718 bearings and new shaft (12) P/N 5603069-1 as described in (D.) below.
- (2) If grease is present, use mineral spirits, to wash all grease from the needle and thrust bearings.
- (2) Inspect bearings for excessive wear, damage and freedom of movement. Replace if defective.
- (3) Use a clean lint free cloth saturated with mineral spirits to remove grease and foreign material from the bearing races.
- (4) Inspect the races for excessive wear or damage and replace if defective.
- (5) Pack the thrust bearings with MIL-PRF-81332 grease.

- (1) Place spacers (10) and thrust plate (17) on shaft (12).
- (2) Install thrust bearings (16) in control column.
- (3) Slide shaft (12) through thrust bearings (16) and install thrust plate (17), shims (10), and collar (19) on shaft (12). Align holes in collar (19) and shaft (12).
