SERVICE LETTER NO. 70-8

SUBJECT: Rudder Bellcrank Modification

MODELS AFFECTED: AA1-0001 thru 0310, 0312 thru 0332, 0334 thru 0346, 0348 thru 0350, 0352 thru 0375, 0377 thru 0378, 0380 thru 0403, 0405, 0407, 0409, & 0411.

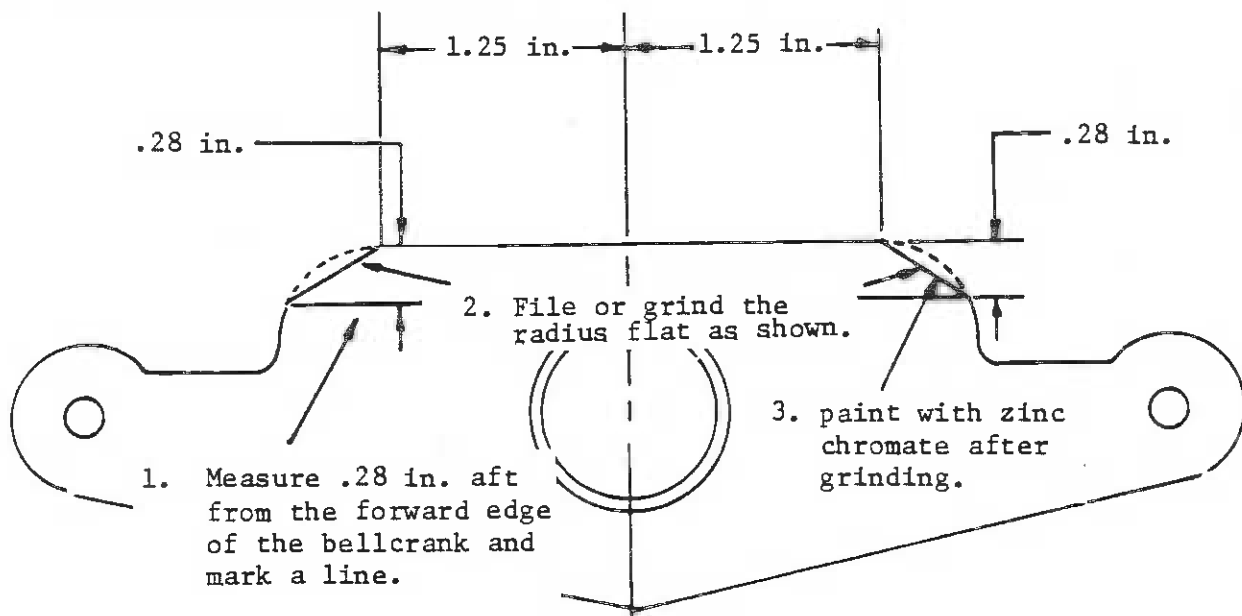
Figure 1. Rudder Bellcrank Modification Procedure.

Field reports indicate that on some aircraft a camming action is taking place between the rudder bellcrank and the bellcrank stop bolts due to the radius on the bellcrank at the stop contact point. It is suggested that the bellcrank be modified to provide a flat contact area between bellcrank and stop bolts at the next scheduled inspection, or sooner at the owner's discretion.

3. Rework the rudder bellcrank as shown on figure 1.
