Gulfstream American  
Gulfstream American Corporation  
P.O. Box 2206 Savannah, Georgia 31402

SERVICE LETTER NO. 71-4

DATE: June 4, 1971

- SUBJECTS:
- Item 1. Seat Track Improvements
  - Item 2. Canopy Track Improvements
  - Item 3. Windshield/Canopy Hardware Improvements
  - Item 4. Exhaust Joint Sealing
  - Item 5. Nose Gear Inspection and Precautions
  - Item 6. Nose Gear Strut Sealing
  - Item 7. Static System Improvements
  - Item 8. Air Vent Improvements
  - Item 9. Fuel Selector Valve Lubrication
  - Item 10. Lycoming Service Instructions 1070C and 1237

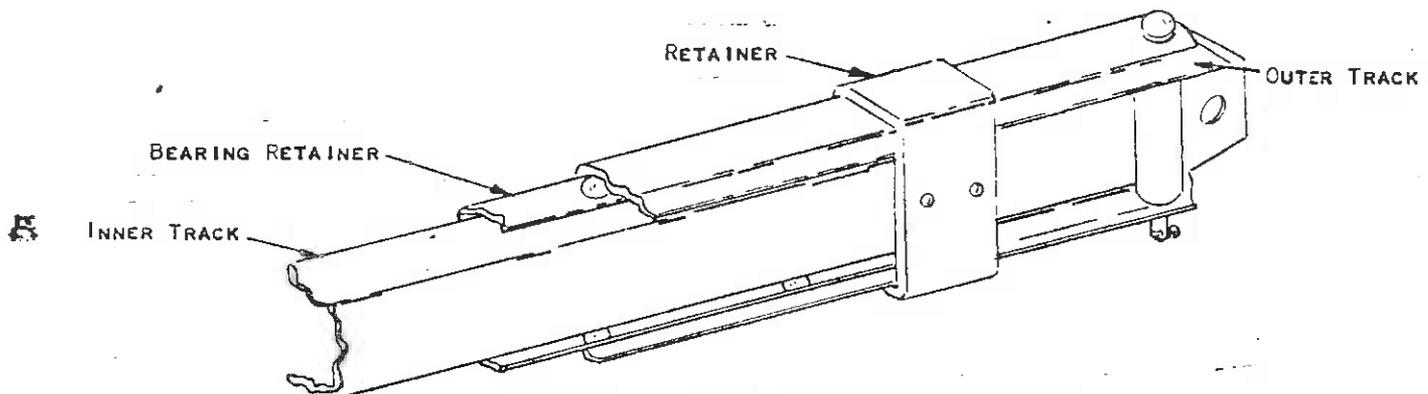
Figure 1. Seat Track Modification

Reports from the field indicate that, in some instances, seat track binding has occurred on aircraft subjected to excessive aft loads on the seat backs. Binding is caused by twisting and eventual bending of the outer track which allows the seat track bearings to drop out.

Improved seat track assemblies have been developed which incorporate retainers (3 per seat), riveted to the ends of the inner track and enclosing the outer track. The retainers prevent the outer track from springing and twisting when excessive aft loads are exerted against the seat back (see figure 1).

When installing 102323-505 inboard track assembly on aircraft serials AA1-0001 thru AA1-0457 and AA1A-0001 thru AA1A-0125, a slight interference will be noted between the forward retainer on the co-pilot inboard seat track and the flap motor cover area of the console. Modify the console interference area using a hot iron (225°F), as shown below. (Place a piece of cloth between iron and console to prevent sticking.)
