SERVICE LETTER NO. 72-3

DATE August 7, 1972

SUBJECTS: ITEM 1. STEP DRAIN HOLE MODIFICATION  
ITEM 2. FLAP POSITION INDICATOR MODIFICATION  
ITEM 3. AILERON BALANCE WEIGHT ARM MODIFICATION  
ITEM 4. CANOPY LATCH AND LOCK SEALING IMPROVEMENTS  
ITEM 5. CANOPY TRACK TEFLON RUNNER ROLL PINS  
ITEM 6. REAR SEAT CLOSE OUT COVERS  
ITEM 7. TAIL TIE DOWN RINGS

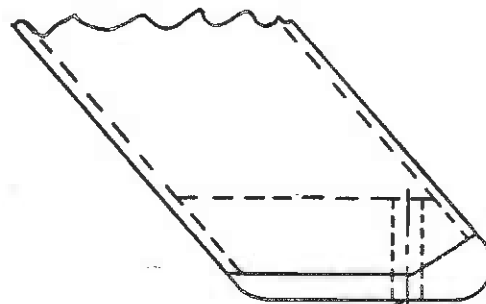
On production aircraft, AA5-0027 and up, the optional outside steps have been redesigned to include 3/16" diameter drain holes through the bottom caps to prevent an accumulation of moisture inside the steps. Aircraft prior to AA5-0027, which are equipped with the optional outside steps, should have these drain holes added. See Figure 1 below for the proper location of these holes.

Drill 3/16" dia. thru.

.85 ±.06

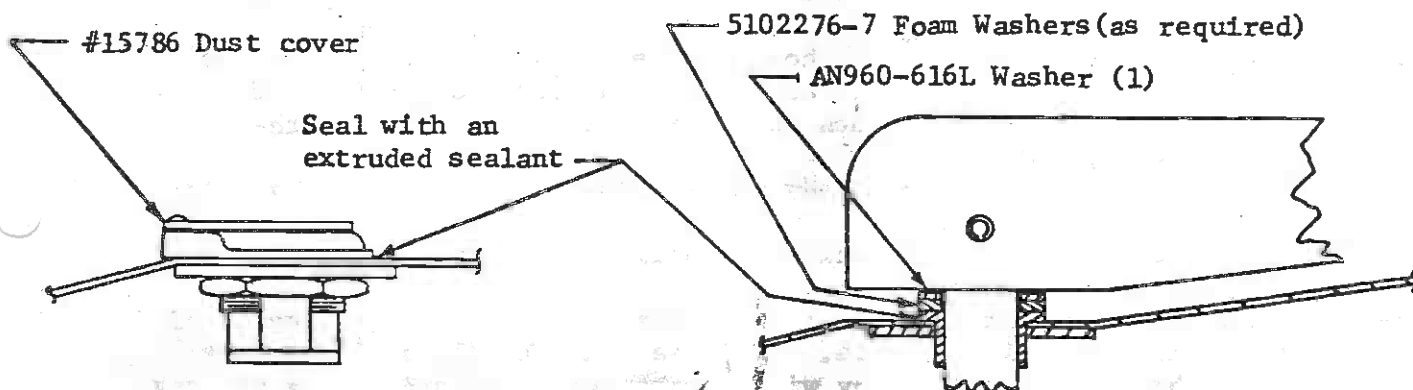
Figure 4A.

Changes have been incorporated on recent production aircraft to improve sealing in the canopy latch area. The faying surface of the canopy latch handle shaft nyliner bearing is sealed to the canopy with an extruded sealant\* when the bearing is installed. One AN960-616L washer(directly under the latch handle) and foam tape washers, Part No. 5102276-7 are installed, as required to fill the gap between the outside canopy latch handle and the canopy top skin to seal the latch handle shaft where it passes through the canopy skin. Additionally the canopy lock body is sealed to the canopy with an extruded sealant and a dust cover is now used over the key slot. These improvements can be made on earlier model aircraft as follows:

Canopy Lock and Latch Sealing Improvements

1. Remove the canopy handle and the shaft nyliner bearing.
2. Remove the royalite trim panel covering the canopy latch box assembly inside the canopy.
3. Remove all the screws holding the latch box assembly to the canopy and spring the aft end of the box assembly down far enough to allow wrench clearance for the 7/8" nut on the canopy key lock.
4. Remove the key lock body and slip on the dust cover assembly #15786.
5. Reinstall the key lock body sealing it to the canopy with an extruded sealant\*.
6. Reassemble the latch box assembly to the canopy in reverse of the removal procedure. Seal the latch handle shaft nyliner bearing to the canopy with an extruded sealant\* wiping off any excess.
7. Install foam washers(P/N 5102276-7) adhesive side up as required and one AN960-616L washer to fill the gap between the canopy top and the latch handle. Install the handle. See Figure 4A and 4B.

1. Remove the outside canopy latch handle(and any washers underneath it).
2. If the latch handle shaft bearing is not sealed to the canopy remove it, apply extruded sealant\* to the mating surfaces and reinstall it in the canopy.
3. Install foam washers(P/N 5102276-7) adhesive side up as required, and one AN960-616L washer, to fill the gap between the canopy and the handle. Reinstall the latch handle.

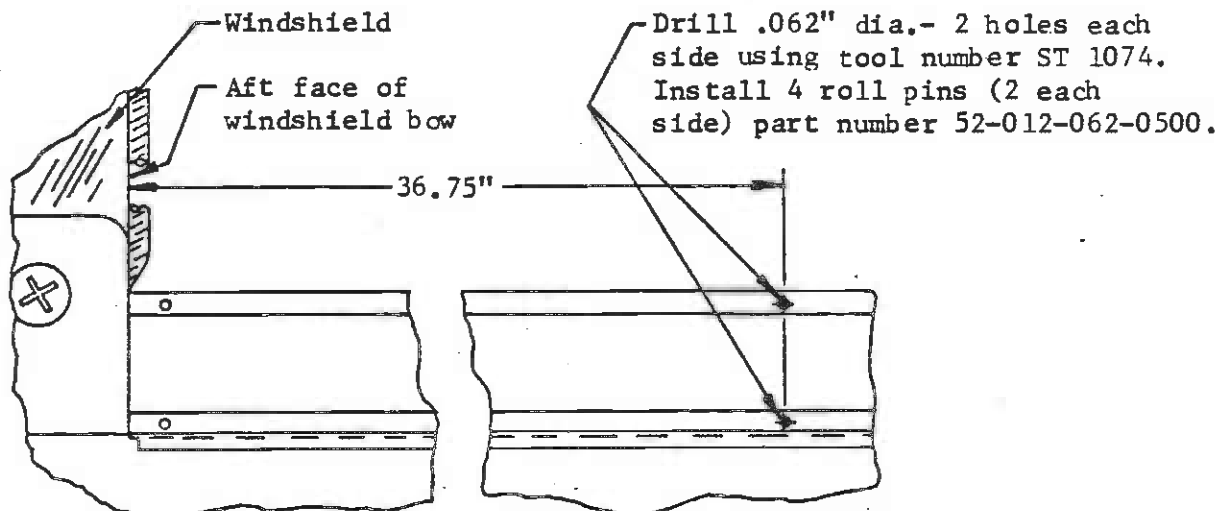
Figure 5. Canopy Track Modification.

AA5-0146 and on have four additional roll pins installed in the canopy track assembly to provide improved retention of the teflon runners. These roll pins can be installed on aircraft below AA5-0146 by removing the two canopy stops and carefully sliding the canopy aft far enough to insert the canopy track drilling tool #SF-1074 and drill the .062" diameter holes 36.75" from the front of the track, (see Figure 5). The installation of these new roll pins is identical to the existing ones at the front of the track. After the pins are installed slide the canopy forward and replace the canopy stops.

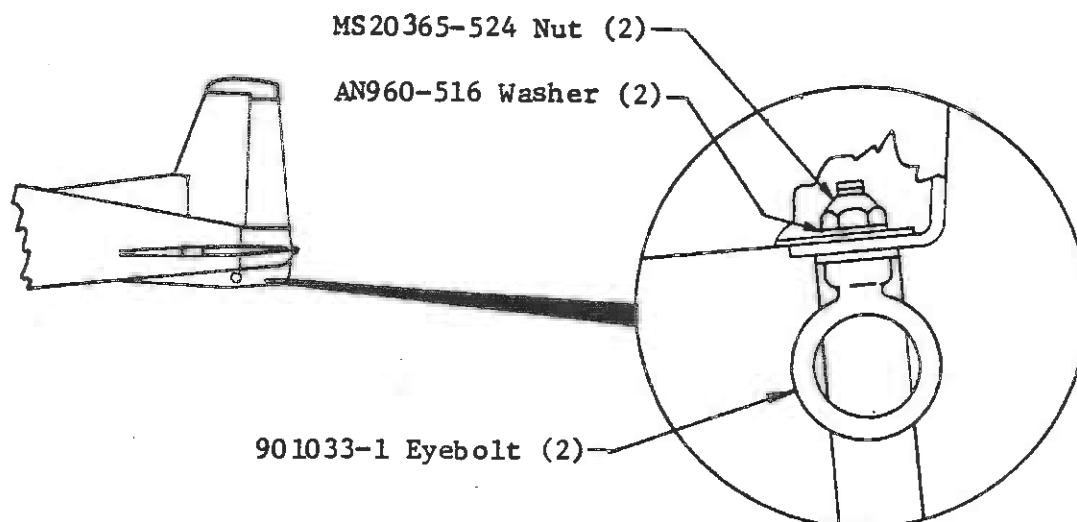
Figure 7. Tail Tie Down Rings.

On production aircraft AA5-0047 and up two tail tie down rings (one on each side of the ventral fin) have been added to the bottom of the fuselage below the rear stabilizer bulkhead. These eye bolts can be added to aircraft AA5-0001, through AA5-0046 as follows:

Take off a rear access cover, remove and discard the existing bolts, nuts and washers that attach the ventral support braces, to the bottom of the fuselage. Enlarge the holes in the braces and the corresponding holes in the bottom of the fuselage to 5/16" diameter and install the eyebolts, washers and nuts, (see Figure 7). Prime and paint the eyebolts the aircraft color.
